Coil clean with Viper Brite leads to performance gains

Despite undergoing refrigeration and air conditioning refurbishment works in 2019, the performance of one Sydney supermarket's main air handling unit (AHU) cooling coil had been adversely impacted due to the continuous build-up of hard carbon contamination deep within the coil fins and rows.

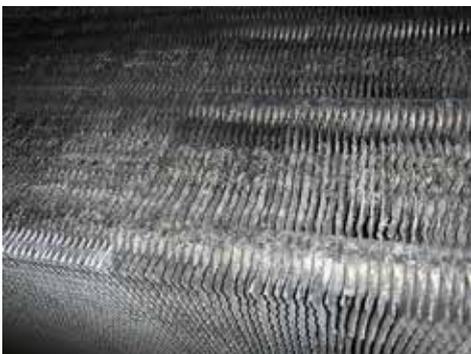
Over the years many attempts to remove the contamination had been made by service technicians using a variety of products and cleaning techniques. Whilst some of the carbon was able to be removed from the surface of the coil, these practices had conversely contributed to the hard carbon particles being further embedded into the coil (see image 1).

Image 1: Hard carbon contamination was quite evident not only on the surface of the coil, but also deep within the fins and rows.

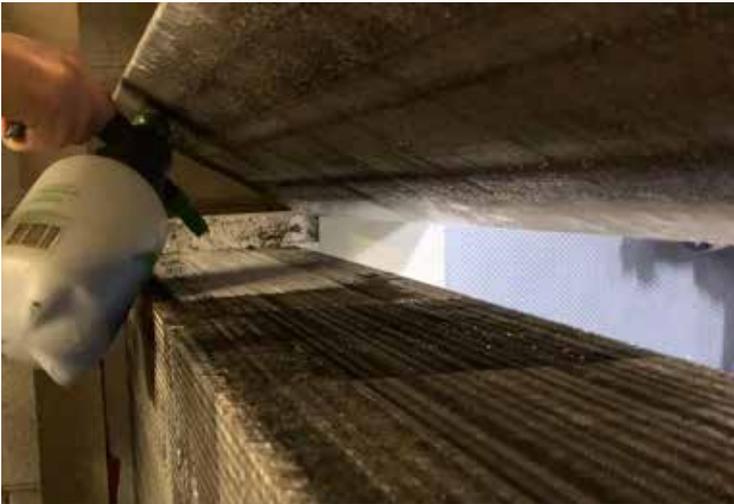
Image 3: Initially Viper Brite was applied on a small section from the left side on the air onto the coil.

1. Initially, Viper Brite was applied on a small section approximately 50cm wide from the left side on the air onto the coil (see image 3).
2. Starting at the bottom, Viper Brite was sprayed onto the coil letting the chemical fill over the tube runs of the coil. This allowed the foaming action to take place and commence the process of pushing out and removing the hard carbon from deep within the coil (see image 4).
3. After 10 minutes the foam had stopped reacting and liquefied, indicating it was time to rinse. A high pressure washer was used to rinse this section of the coil. (see image 5). This step was repeated in each section left to right across the coil.

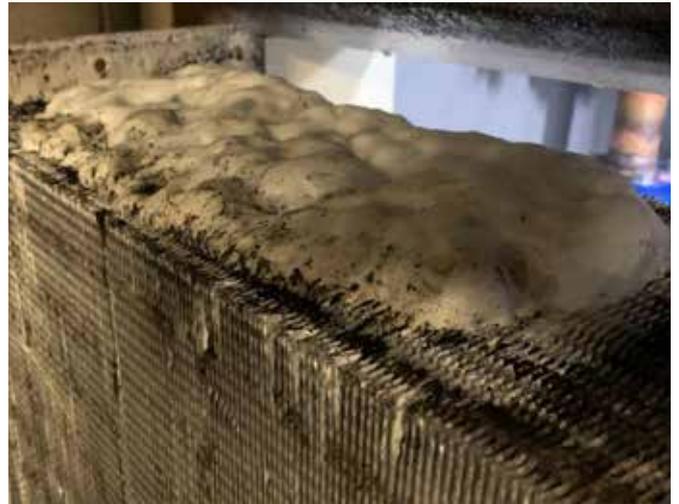
Image 4: Spraying onto the coil initiated the foaming action, pushing out and removing the hard carbon.

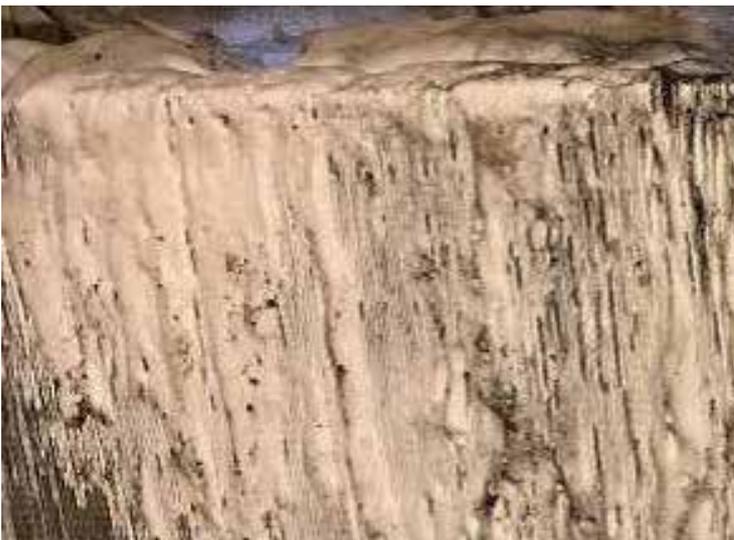
Image 5: When the foam had stopped reacting, it liquified indicating it was time to rinse.

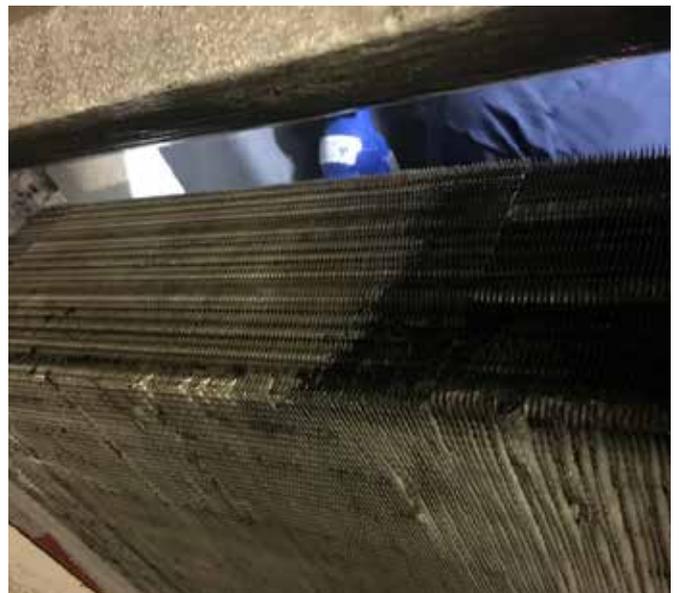
Image 6: Result after the first application and rinse.

The amount of contaminants that were dislodged from the coil with every high-pressure water rinse was clear evidence that the mass inside the coil was gradually broken down with each application of Viper Brite.

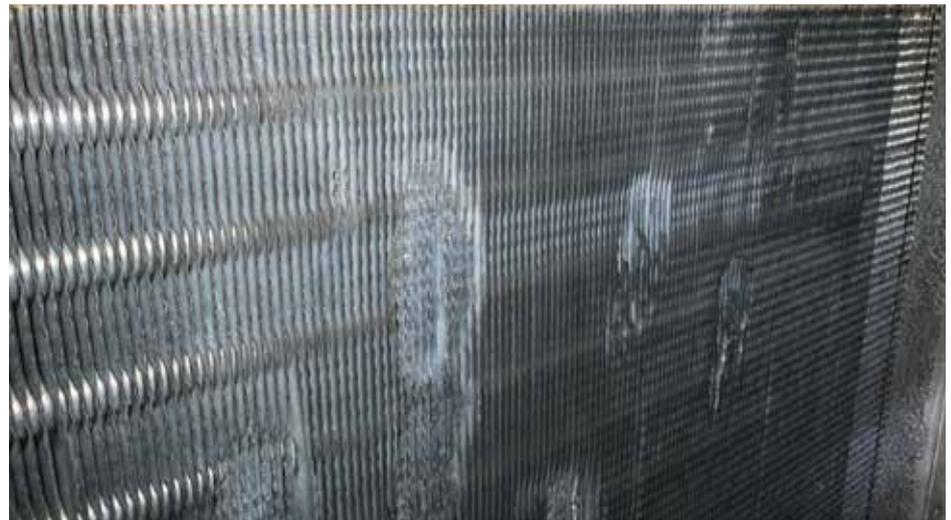
Airflow (Total Flow Rate l/s)			
Before	After	Difference (Actual)	Difference (%)
6,772	8,222	+1,450	+21%
Airflow (Velocity m/s)			
Before	After	Difference (Actual)	Difference (%)
8.36	10.15	+1.79	+21%
Evaporator Fan Current (A)			
Before	After	Difference (Actual)	Difference (%)
18.10	12.90	-5.20	-29%
Evaporator Fan Power (kW)			
Before	After	Difference (Actual)	Difference (%)
13.50	9.60	-3.90	-29%

Results: Data measuring total flow rate (L/s), airflow velocity (m/s), fan current (A) and fan power (kW) was collected before and after using Viper Brite.

Image 7: Added to the improved heat exchange co-efficient of the coil, the immediate result suggests a saving of 15,029 kWh p.a. through the evaporator fans alone.

The trial results confirmed that the Viper Brite product removed a significant amount of hard carbon from the AHU cooling coil, removing significant coil blockages and improving the total airflow by 21%. Additionally, the fan current draw (A) and power (kW) both decreased by 29%.

It can be calculated that an overall saving of 15,029 kWh p.a. can be attributed to just the evaporator fans alone. The total saving coupled with overall system energy is expected to be greater throughout the summer period.
